# Manhole Inspection Summary

Manhole # S19KK\_006MH

**Location** Address: **1911 PULASKI-PAYSON**

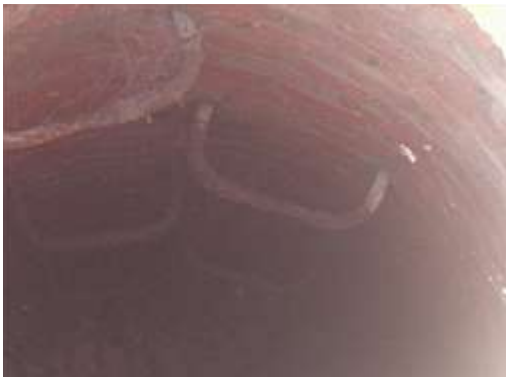
Defect 2

Count: **4** Missing: **0** ☒ **Corroded**

CORRODED STEPS

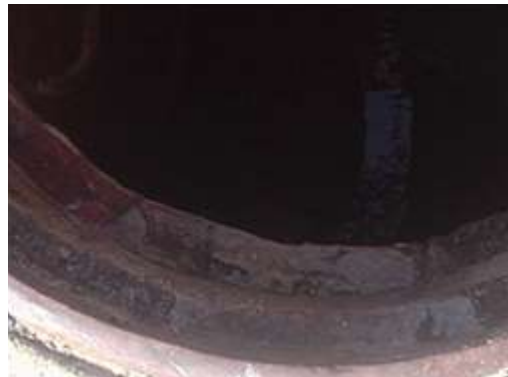
Defect 1

CORRODED STEPS

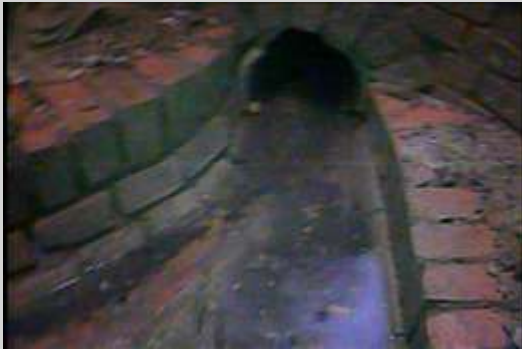
12 O'Clock Outflow

DEBRIS

Pipe Height: **8.4** (in.) Rod and Bar (Angled)  
Pipe Material: **Clay** ☐ Pipe Lined  
Invert Depth: **10.11** (ft.) Flow Characteristics: **Slow**  
Deposits: ☐ None ☐ Mud ☐ Sludge ☒ **Debris** ☐ Grease  
Silt Depth: **2** (in.) Deposits Extent: **Light**  
Infiltration: **None** Pipe Seal Cond: **Broken**

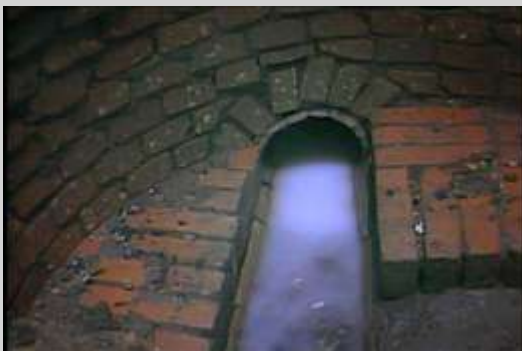
6 O'Clock Inflow

Pipe Height: **7.2** (in.) Rod and Bar (Angled)  
Pipe Material: **Clay** ☐ Pipe Lined  
Invert Depth: **10.04** (ft.) Flow Characteristics: **Slow**  
Deposits: ☒ **None** ☐ Mud ☐ Sludge ☐ Debris ☐ Grease  
Silt Depth: (in.) Deposits Extent:  
Infiltration: **None** Pipe Seal Cond: **Broken**
